Rain erosion of leading edges of wind turbine blades. What is up and down?

Publication date:
2018

WindEurope 2018 Conference at the Global Wind Summit
25 - 28 September, Hamburg

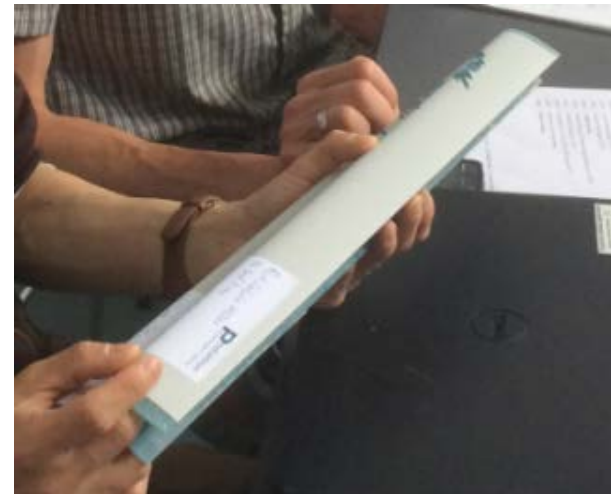
Rain Erosion Tester by R&D Test Systems

Example of specimen
